DeckWise Destructive Compression Testing

Tool Testing Lab, Inc.

Destructive Compression Test

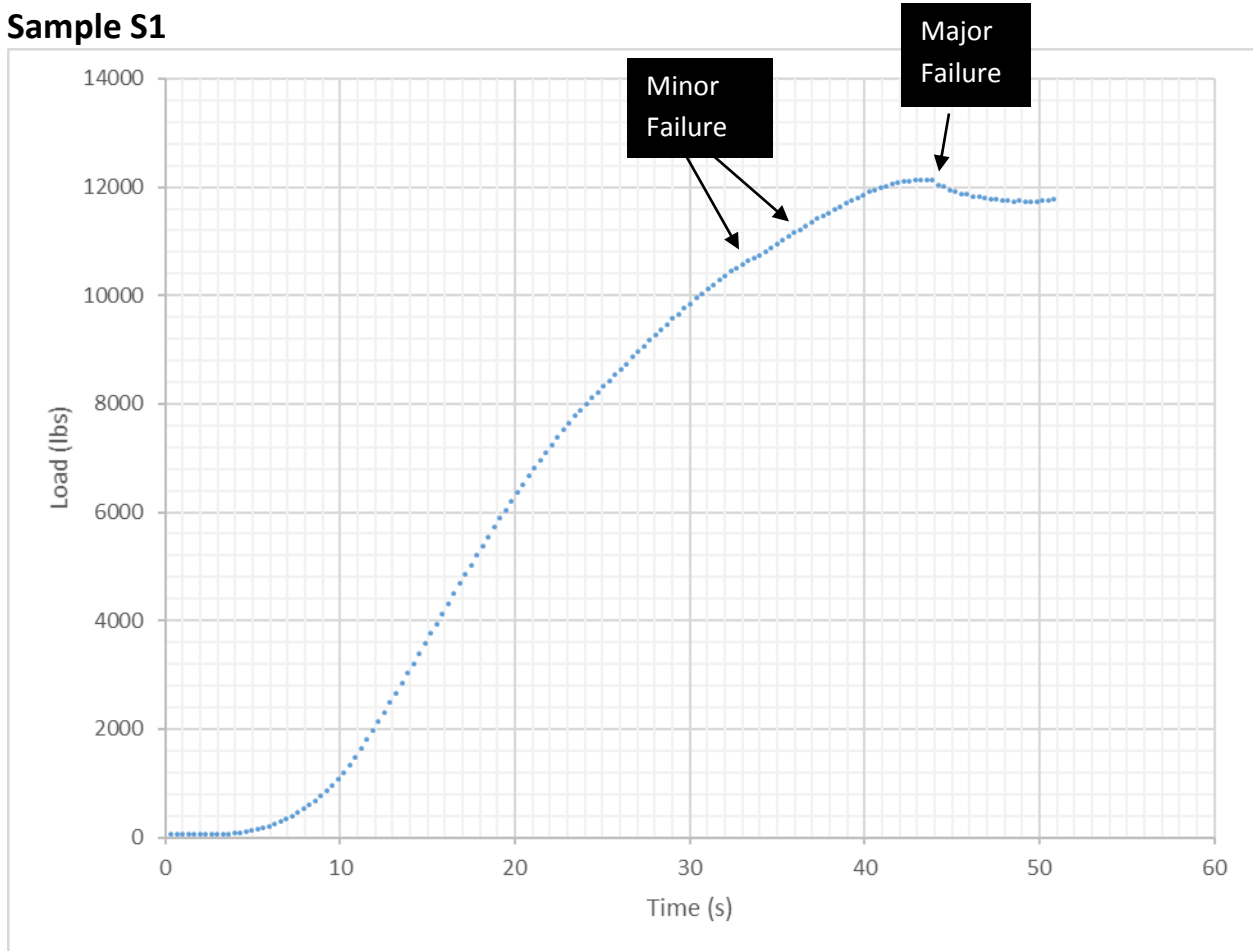
Figure 1

. A few non critical cracks occur around the 34 second mark this can be heard on the video as well as seen by a slight dip in the graph. The sample continued to be loaded until a major crack is heard around the 45 second mark this is also denoted in the graph by a sharp dip in the load signaling a critical failure. This sample failed in top cup.

Sample	Peak Load	Comments
S1	12,135	At Time 43.89 sec. First major failure of top piece
S2	11,941	At time 55.11 sec First Major Failure of top piece
S3	10,374	At time 30.06 First Major failure of top piece
	Ave:11,483

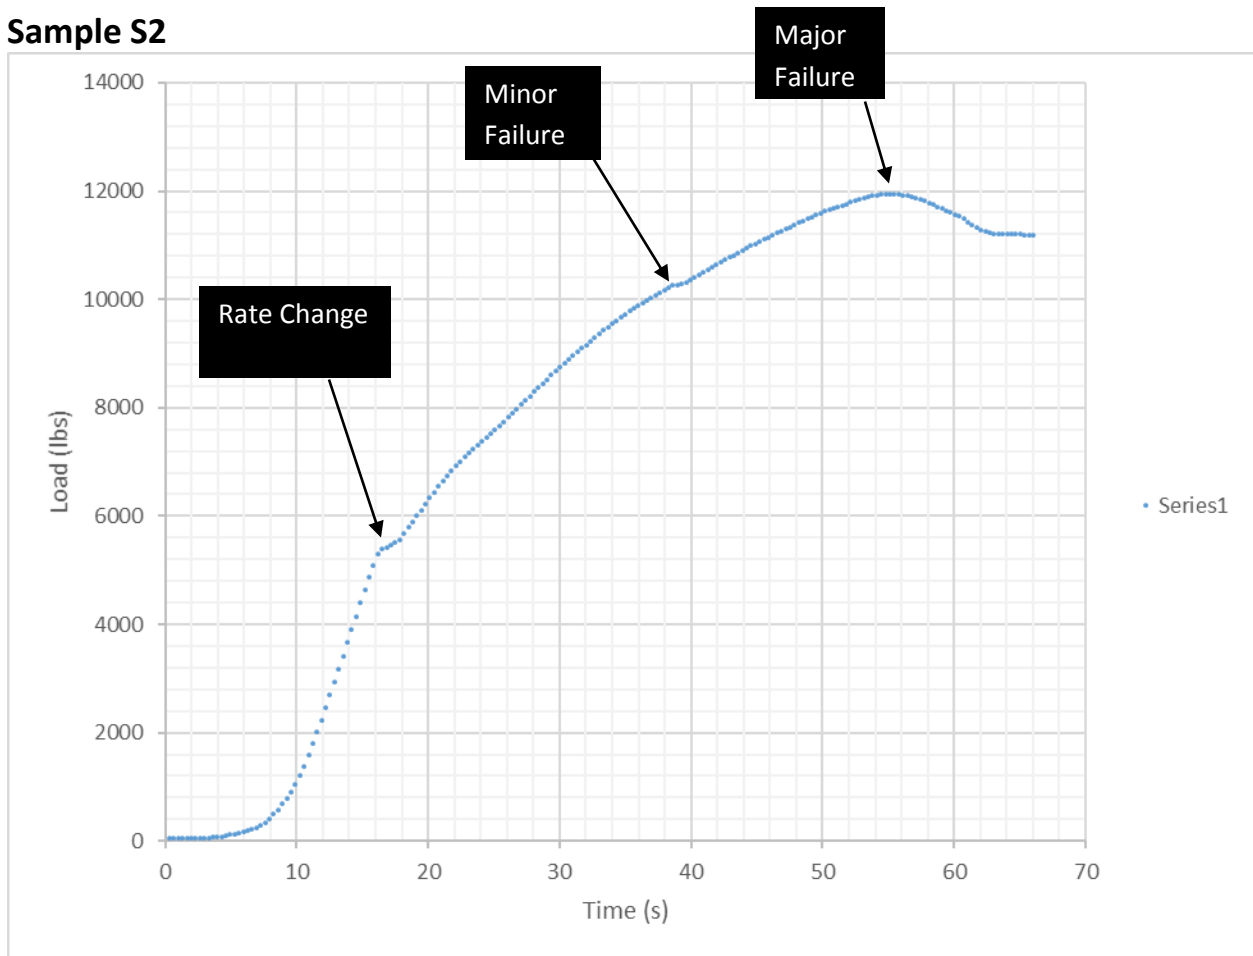
Figure 2

The load rate was slowed around the 13 second mark to allow for better data collection. A non-critical cracks occurred around the 40 second mark and a second non-critical crack occurred around the 45 second mark. The major failure occurred around the 55 second mark. Failure occurred in the top cup of the sample.

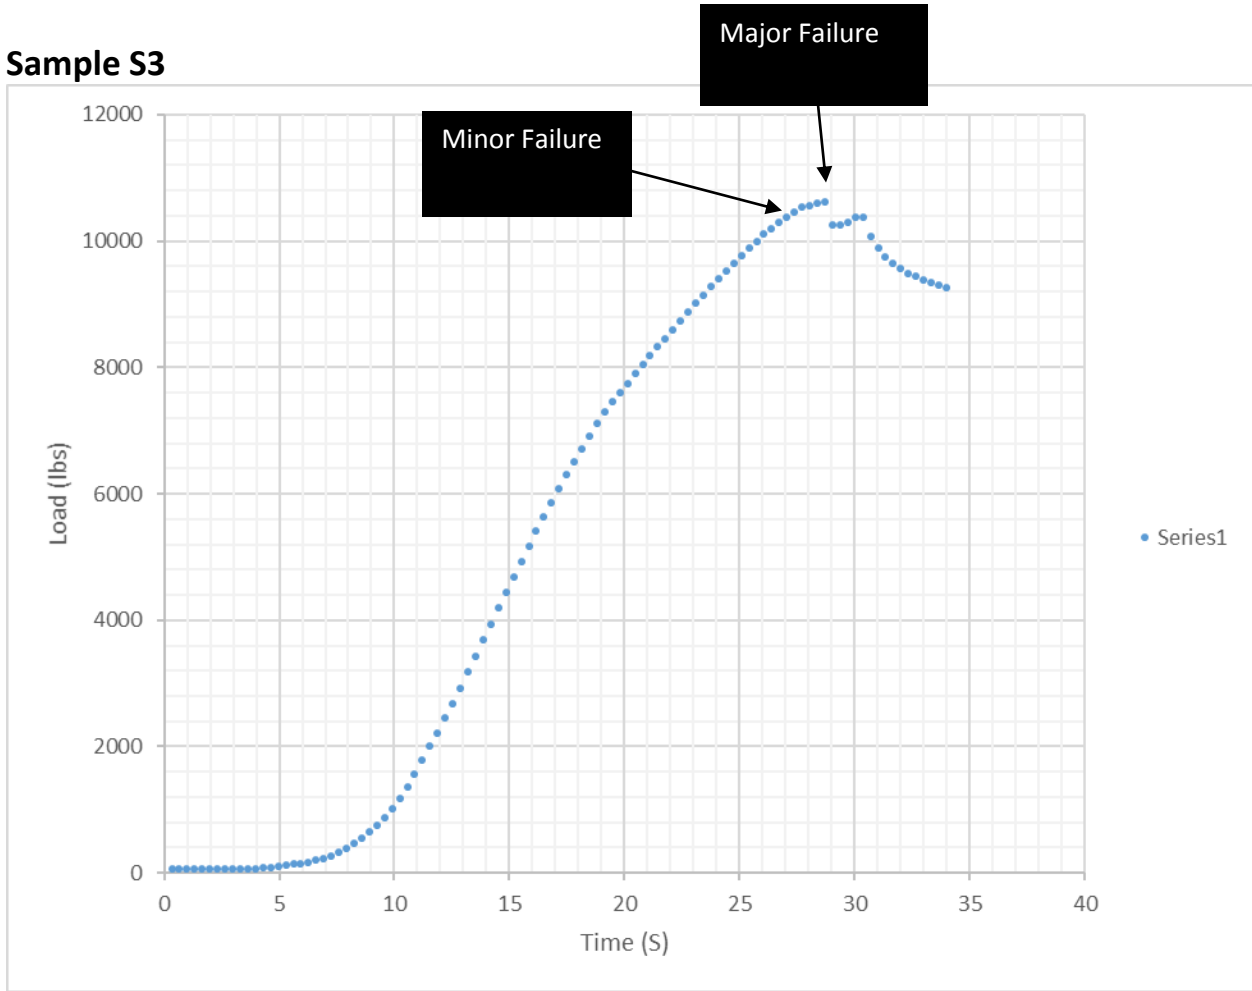
Figure 3.

This sample was loaded at a faster rate than the other samples. For this sample the major and minor failures occurred about the same time, additionally a more distinctive failure was observed. The mode of failure for this sample is the top cup.

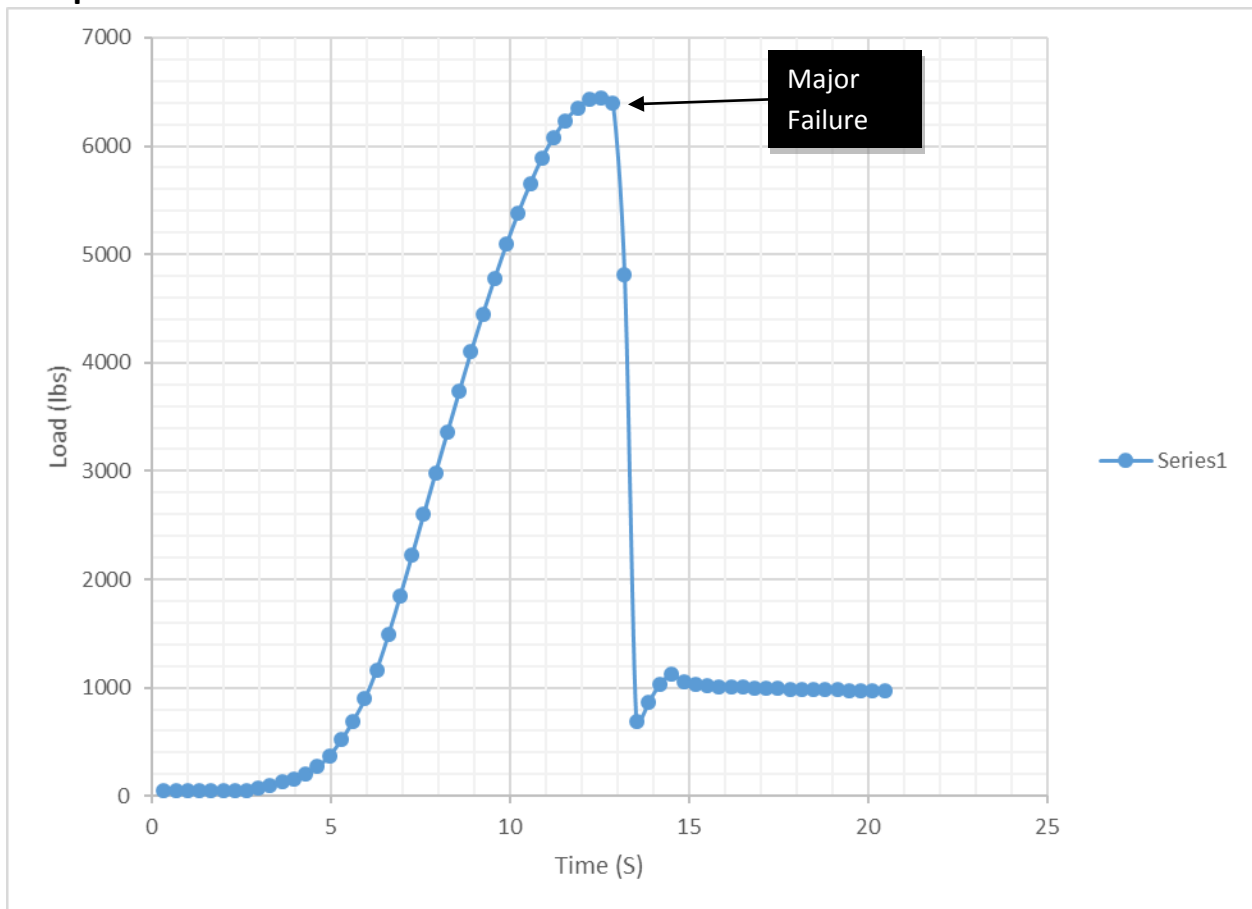
Figure 4.

In this test the failure is critical and easy to see it occurs about the 13s of the test. The base is the mode of failure for this test. During testing you can see the base begin to deform then fail.

Sample	Peak Load	Comments
S4	6,445	At Time 12.54 sec. First major failure of bottom piece
S5	6,344	At time 16.17 sec First Major Failure of bottom piece
S6	6,379	At time 16.5 First Major failure of bottom piece
	Ave: 6,389

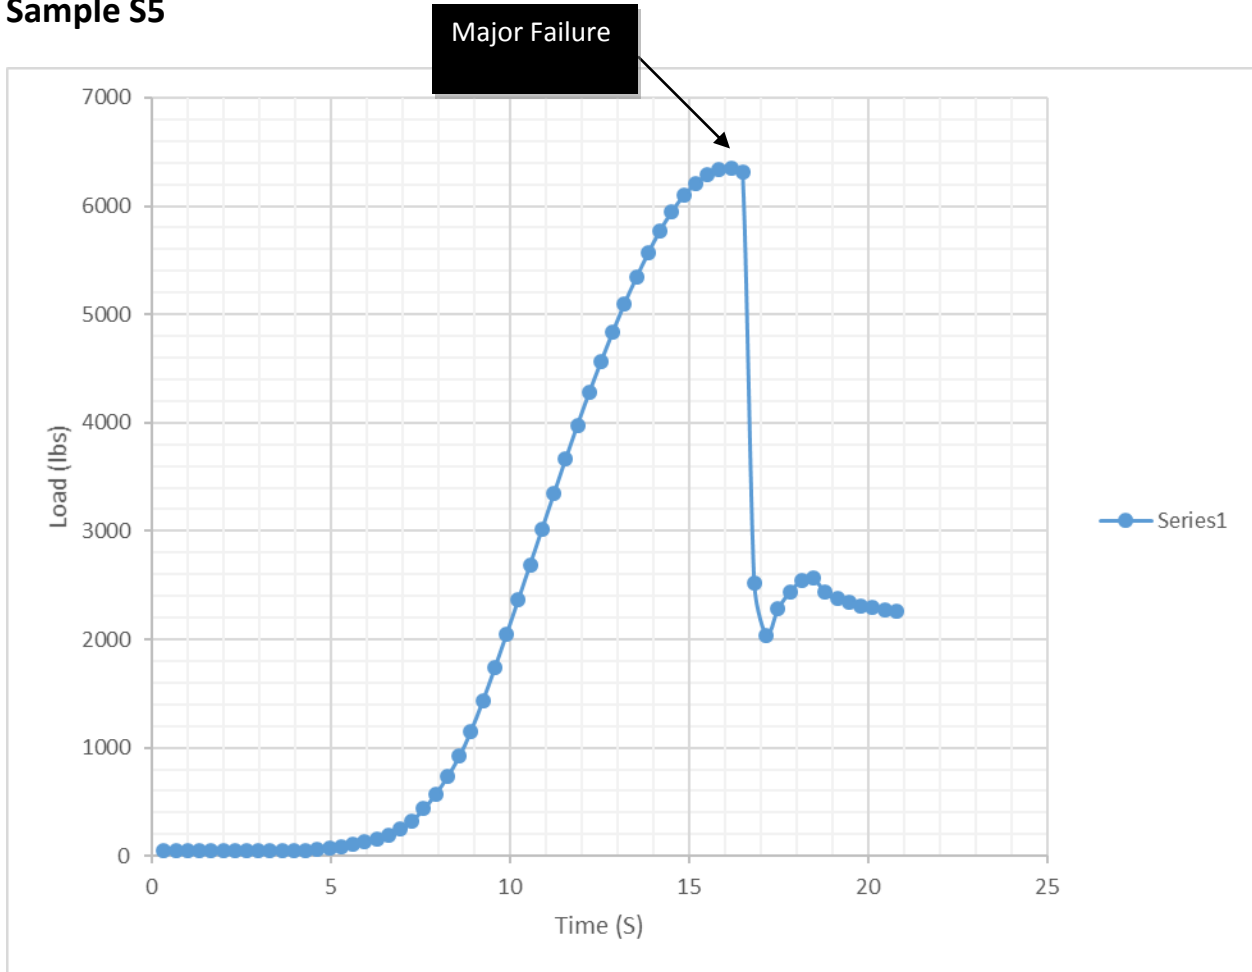
Figure 5

Obvious failure for this test happens around the 16 second mark. Again the part failure mode for this part was the base right at the threads where the mold halves join during injection.

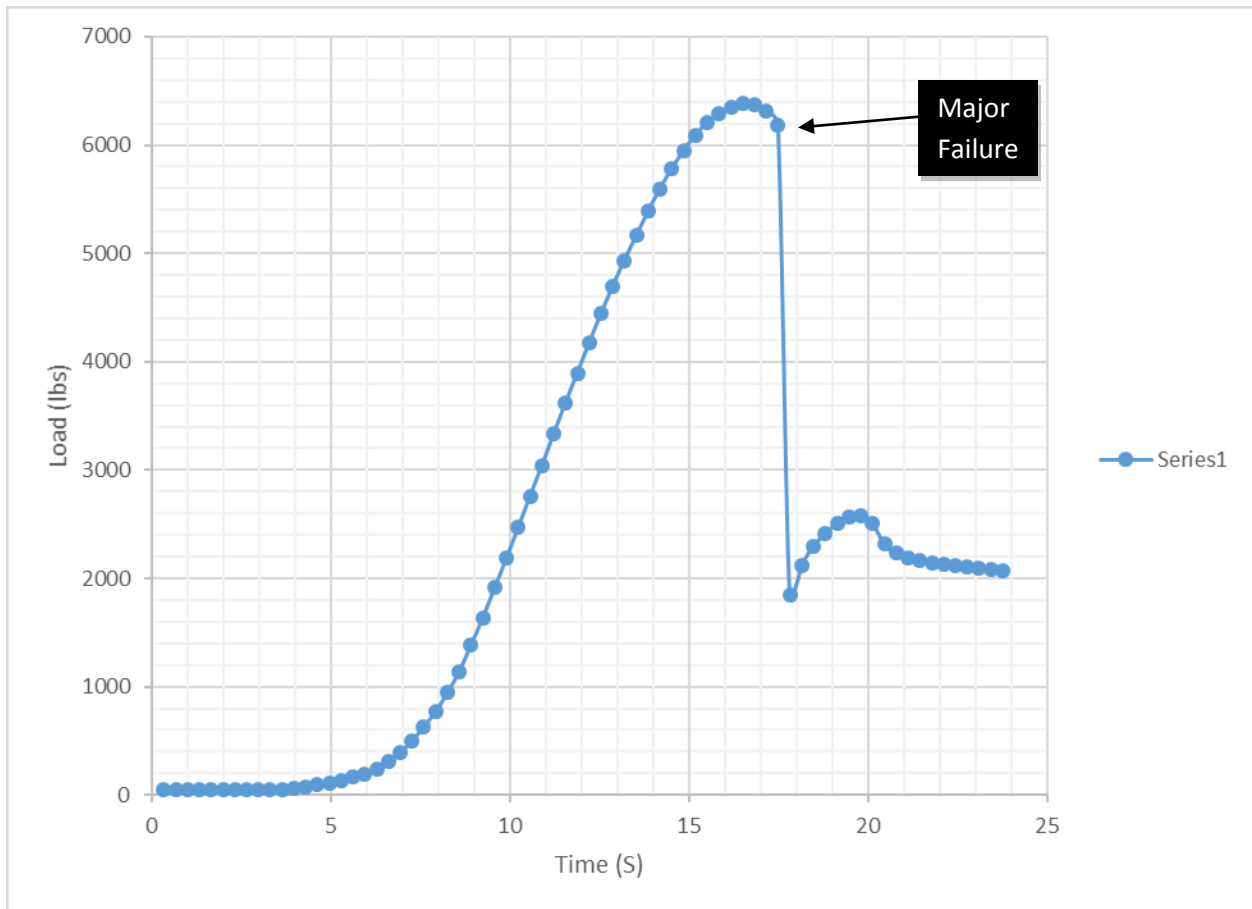
Figure 6

This sample failed at the base. The failure can clearly be at the 17 second mark. Again this failure can be seen during testing as the base section compresses as plastic deformation takes place the black base starts to turn white then failure occurs.

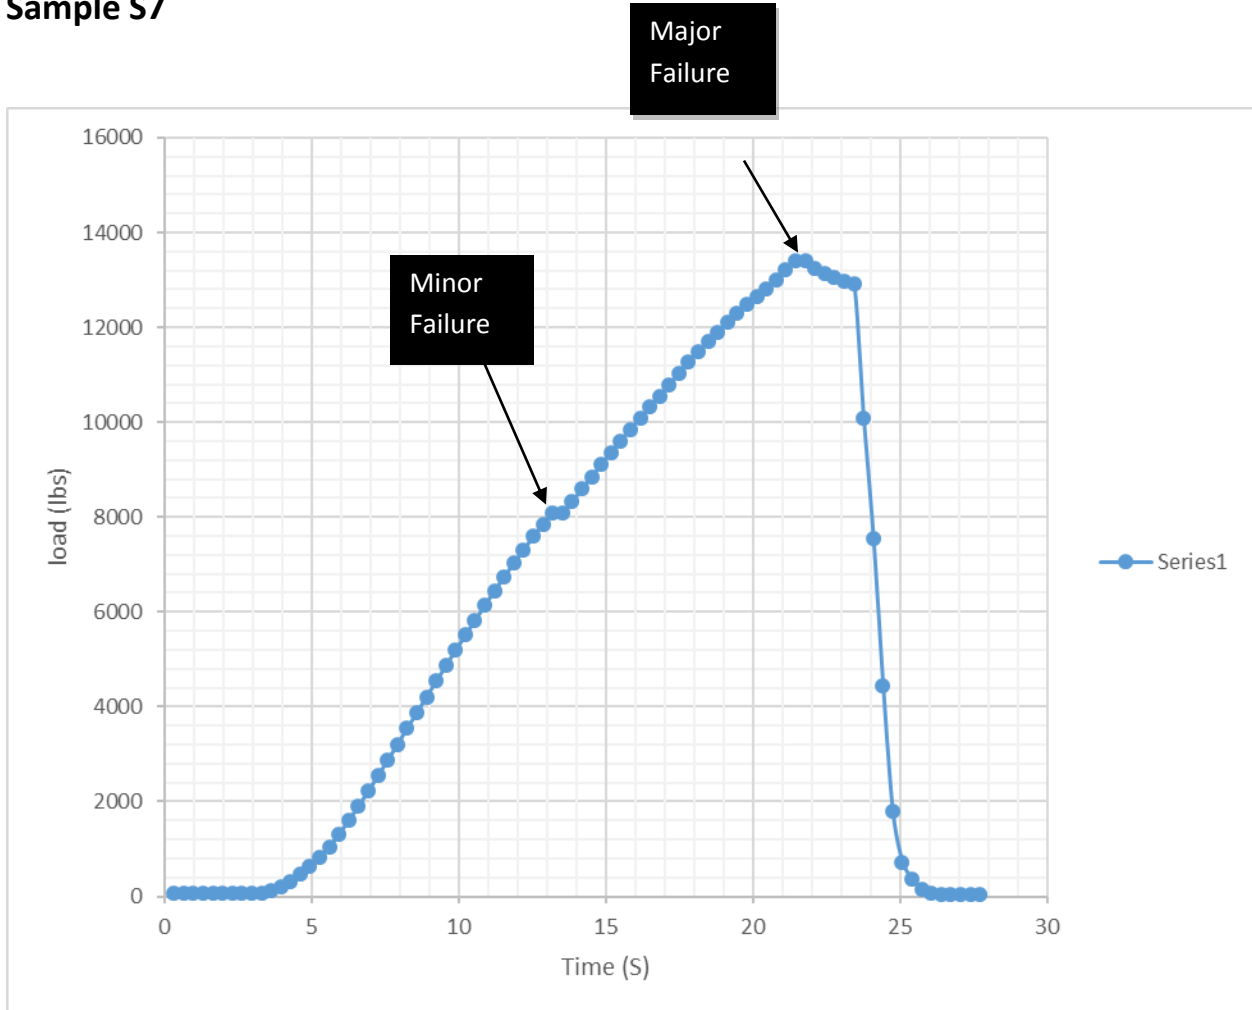
Figure 7

The mode of failure in this test the top cup. A Minor failure happened around 13 seconds loading was continued until a critical failure was reached around 21 seconds. Pressure was released around 23rd second. Resulting the the load drop down to zero.

Sample	Peak Load	Comments
S7	13,407	At Time 21.45 sec. First major failure of top cup
S8	12,589	At time 24.75 sec First Major Failure of top cup
S9	15,822	At time 41.91 First Major failure of top cup
	Ave: 13,939

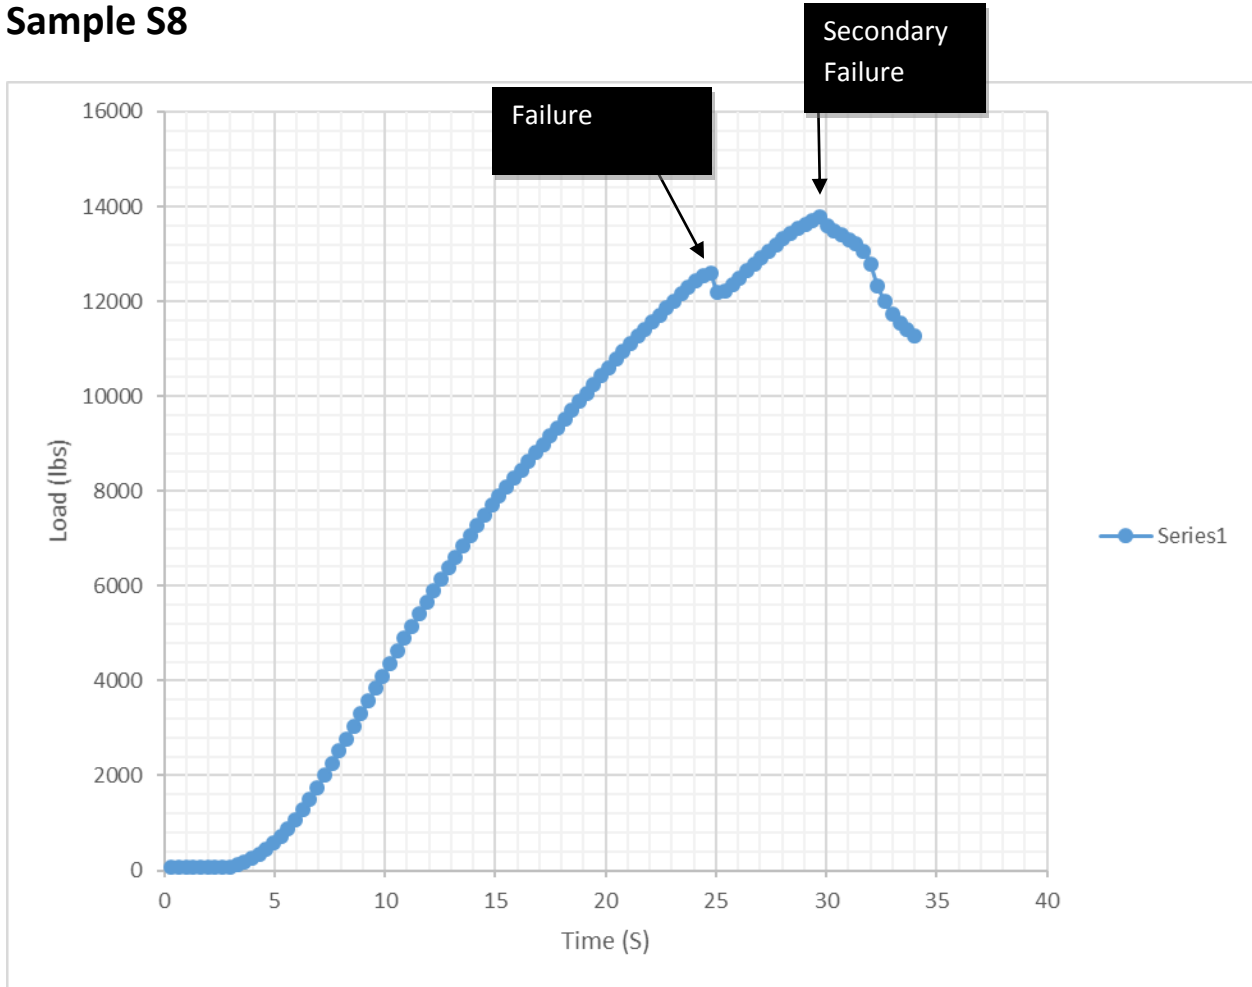
Figure 8

This sample is a little harder to analyze. There is distinctive failure and unloading at the 25 second mark with around 12,300 lbs dropping to around 12,000 lbs. The sample continued to be loaded until a second failure was reported at the 30 second mark. At the 12,000 lb mark would make this sample the lowest failure point by about 1,000 lbs. It is my assesment that the test sample failed at the 25second mark. This conclusion is reached both by the evidence of the sample unloading seen in the graph and a visable jump of the sample in the testing. The mode of failure for this sample is the top cup.

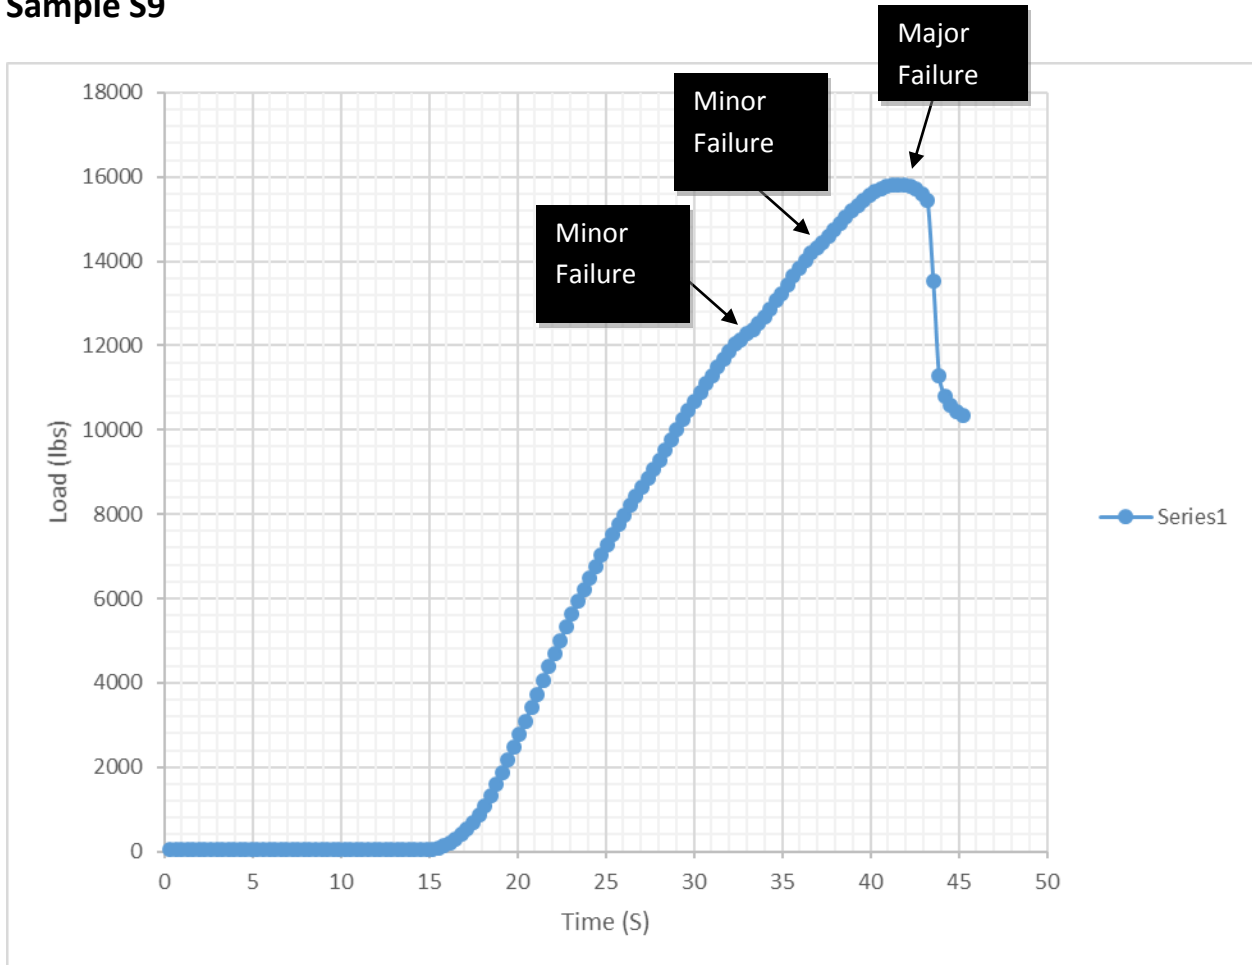
Figure 9

This sample was delayed in starting about about 15 seconds. Loading went of this sample was normal with 2 minor failure the first taking place about the 33 second mark. The second being around the 36 second mark both of these failure can be seen on the graph as well as heard in the testing. The major failure happened 42 second mark and can be seen on the graph. The mode of failure for this sample was the top cup.

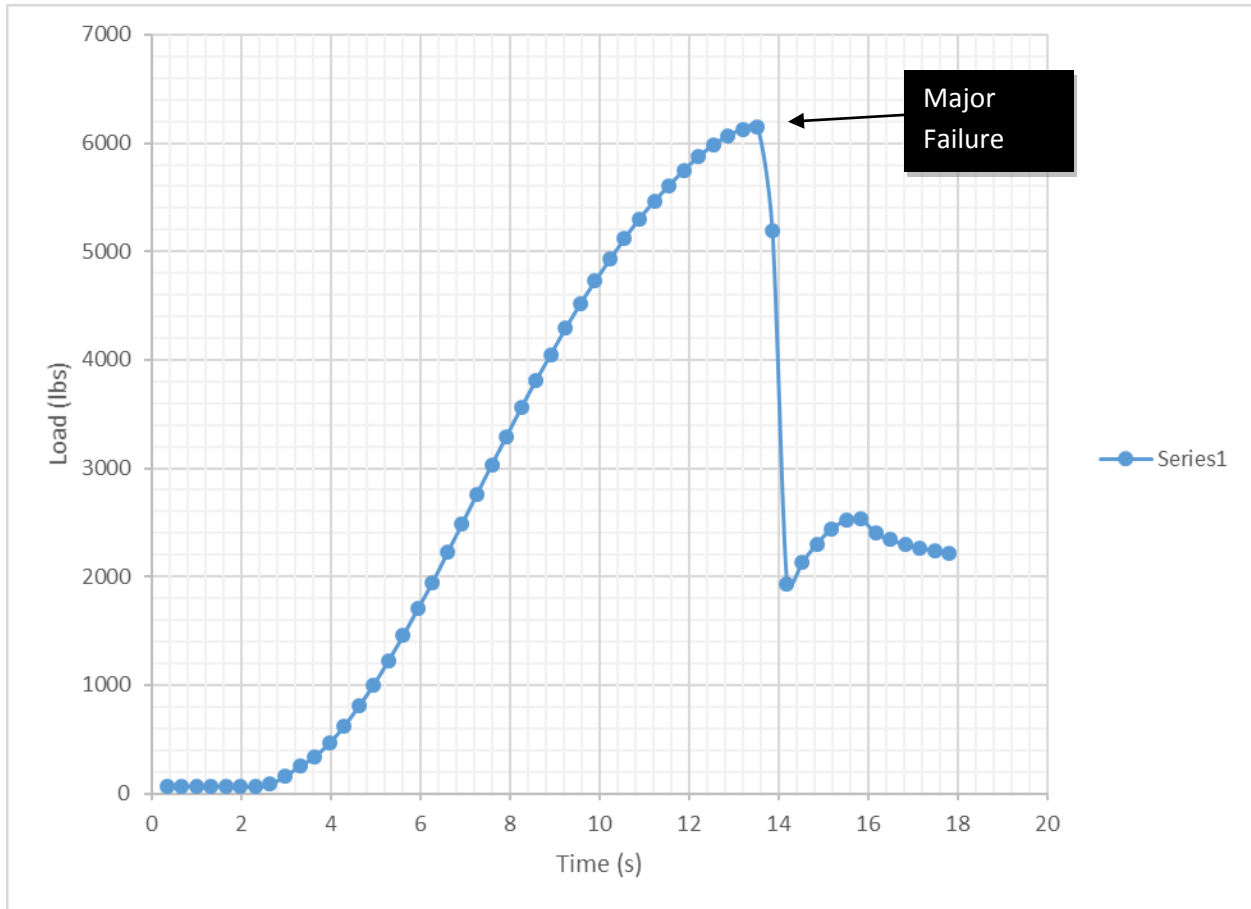
Figure 10

The mode of failure for this sample is the base of the sample. With a similar loading pattern to sample 4,5,6. With a distinctive failure around the 13 second mark. The failure occurred around at the threads in the base.

Sample	Peak Load	Comments
S10	6,145	At Time 13.53 sec. First major failure of Base
S11	5,392	At time 12.87 sec First Major Failure of Base
S12	6,385	At time 12.54 First Major failure of Base
	Ave: 5,974

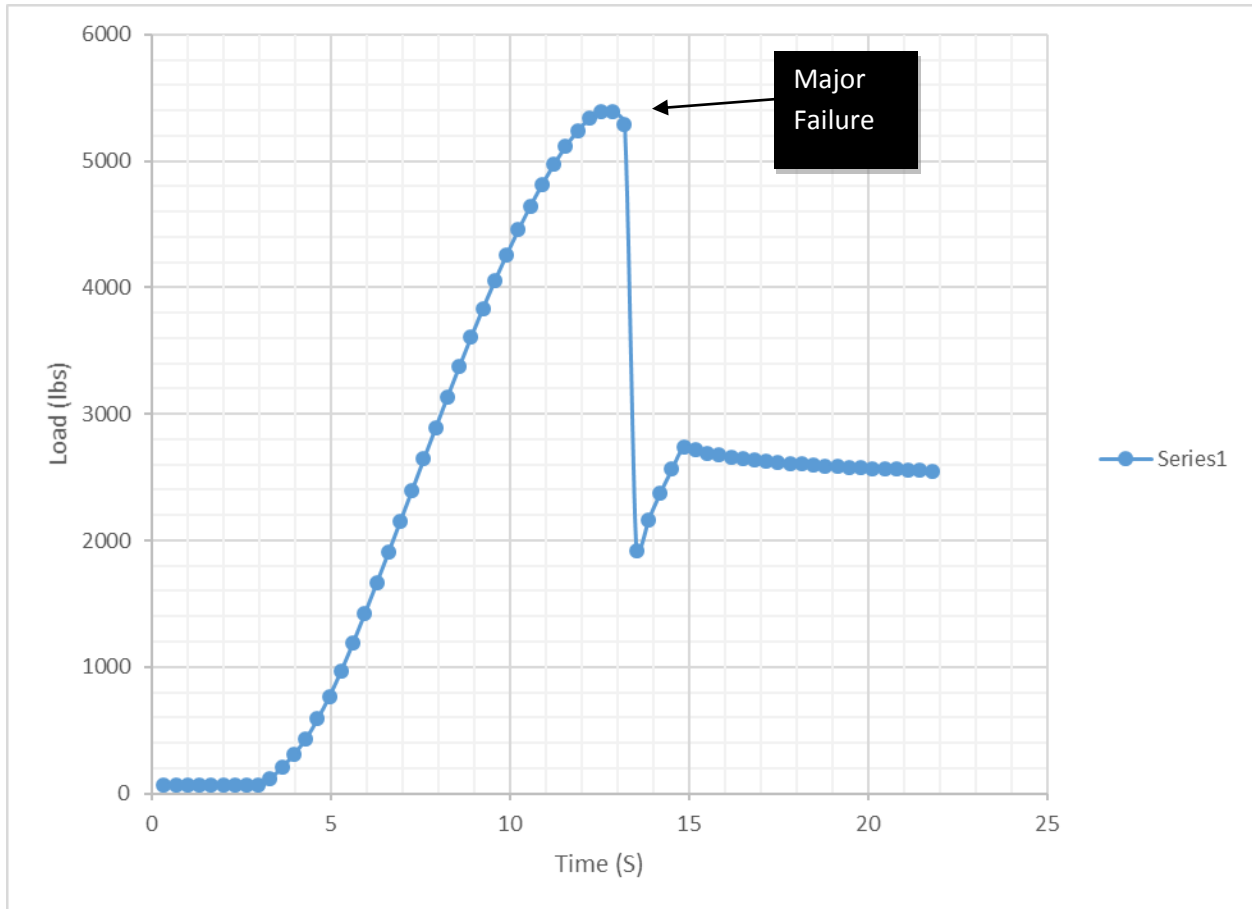
Figure 11
This sample has a major failure at the 13 second mark. This failure occurs at the base with in the threads.

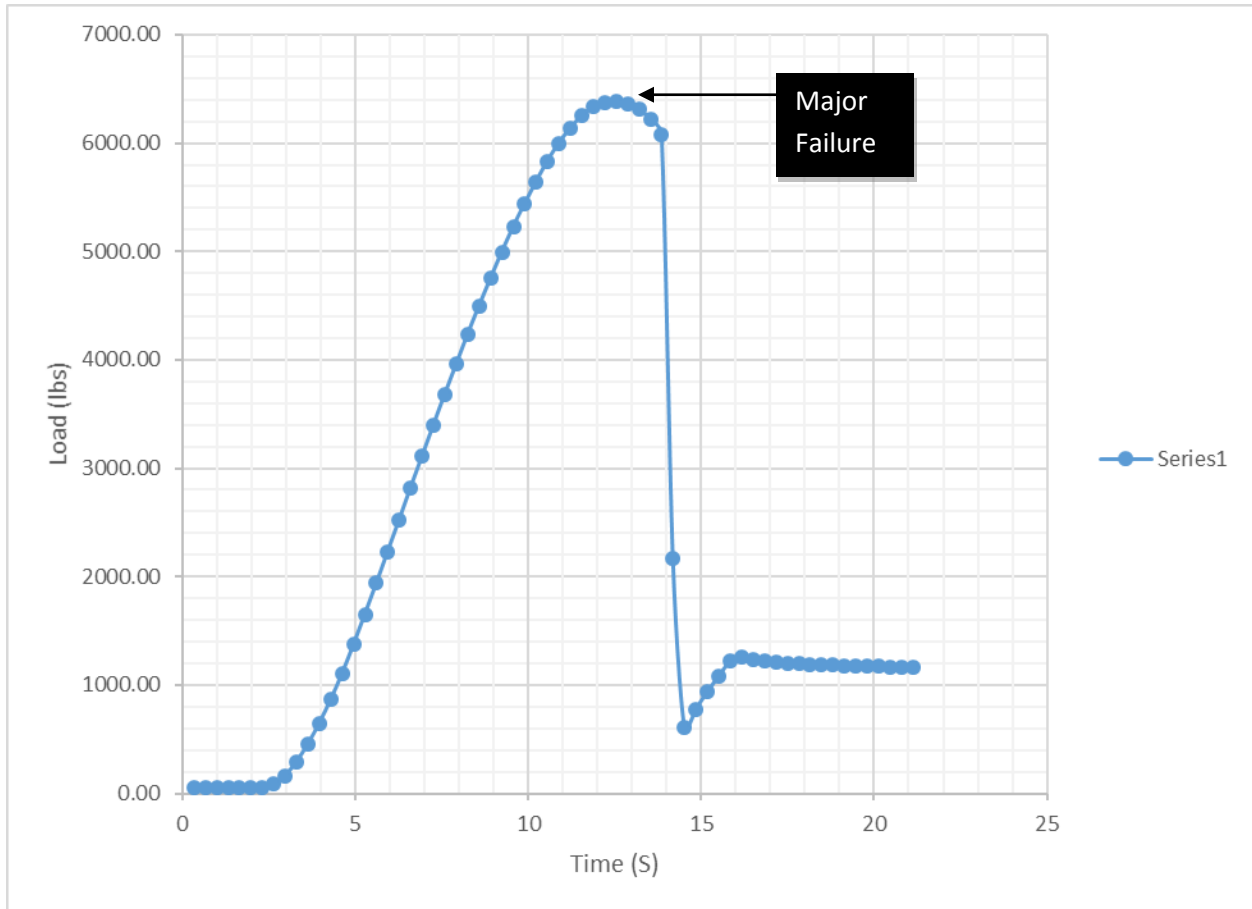
Figure 12

Major failure occurs around 13 second mark at the base of the sample right on the threads.
